SCAPPOOSE BAY
STATE OF THE WATERSHED
2014
Project supported by a grant from the BLM

This report follows from the Scappoose Bay Watershed Assessment (SBWA) (David Evans and Associates, 2000). It describes the current state of the watershed based on the past 14 years of restoration and data collection efforts, and reviews what has been done with respect to the SBWA. This report can be used as a reference to understand current watershed conditions and is a foundation for supporting the Scappoose Bay Watershed Council (SBWC) in developing new priorities and establishing appropriate directions for project development.

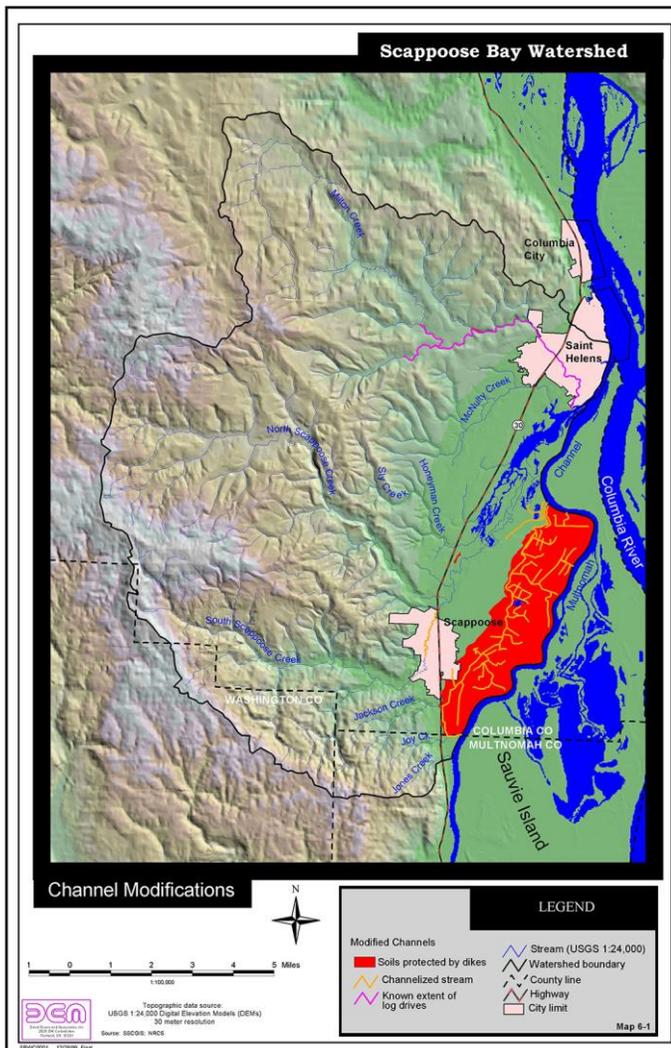
Figure 1-3. Channel modifications of the Scappoose Bay watershed.

- Channel modification and stream alterations: A channel modification map delineates major diked areas, and the effect of log drives and splash dams in Milton Creek was described (see Figure 1-3). The largest channel modification appears to be the routing of Jackson Creek into Joy Creek south of Scappoose. Although most stream systems in the upper valleys have not been modified, clearing the valley floodplains and channels of large wood jams has greatly reduced habitat functions.

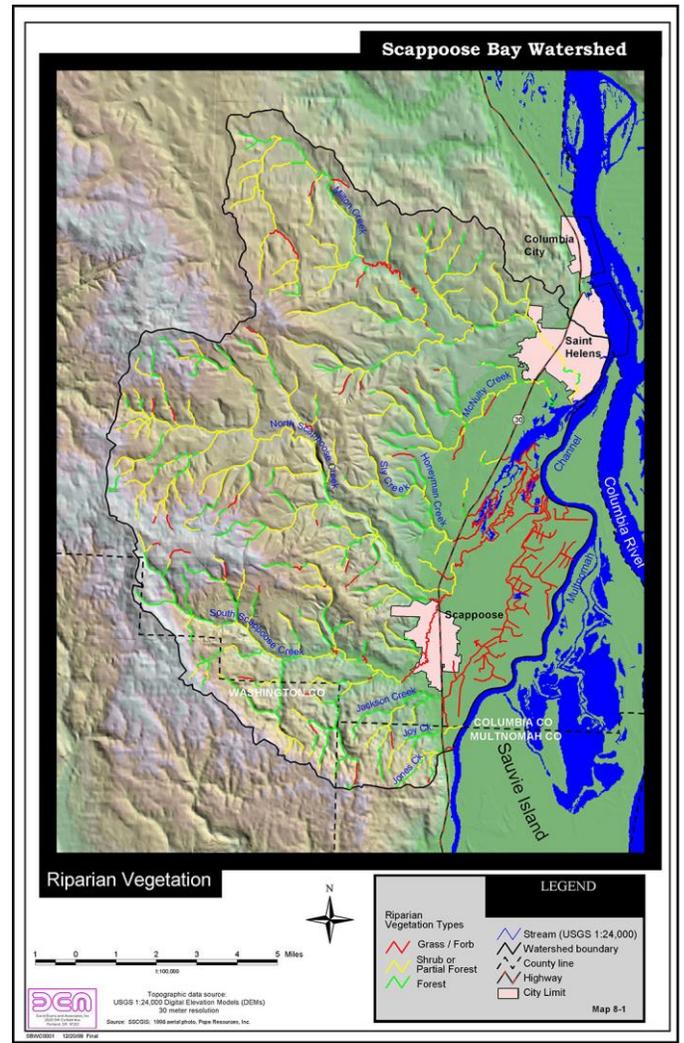
Figure 1-5. Riparian vegetation.

Aerial photographs were used to assess the riparian zone condition for mapped streams, and reaches were classified as grass/forb cover, shrub/partial forest, or forest. Shrubs or scattered trees along the streambanks dominate the current riparian vegetation—a significant change from the historical forested conditions, particularly in the upper watershed (see Figure 1-5).

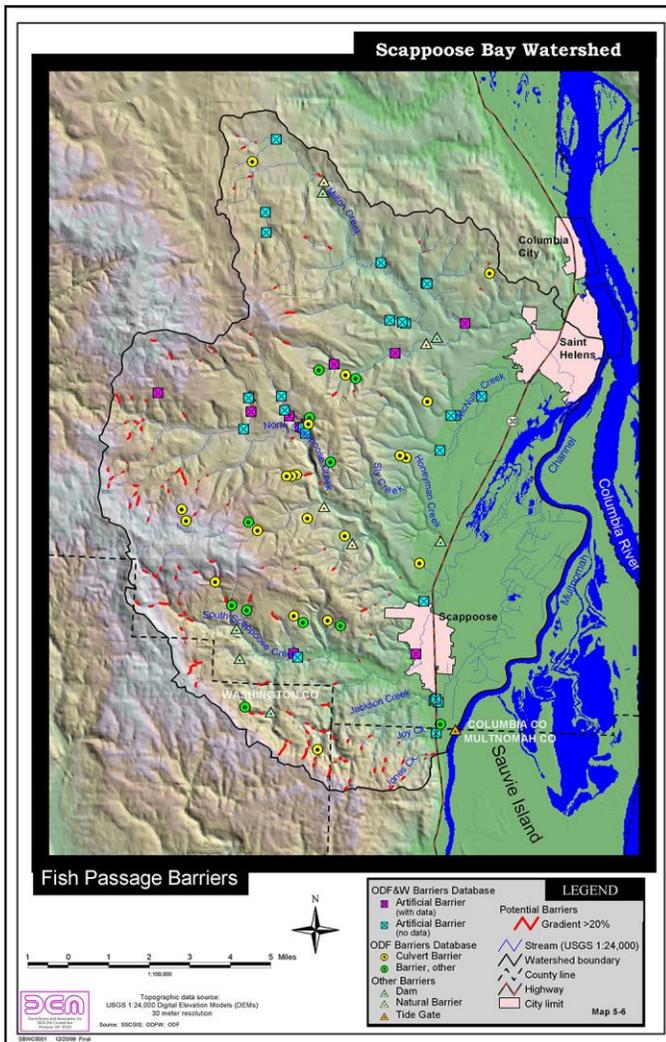
Figure 2-1. Fish passage barriers in the Scappoose Bay watershed identified in the SBWA.

(see Figure 2-1) and a similar map from this study (see Figure 2-2) show the comprehensiveness and detail obtained from the on-the-ground surveys.

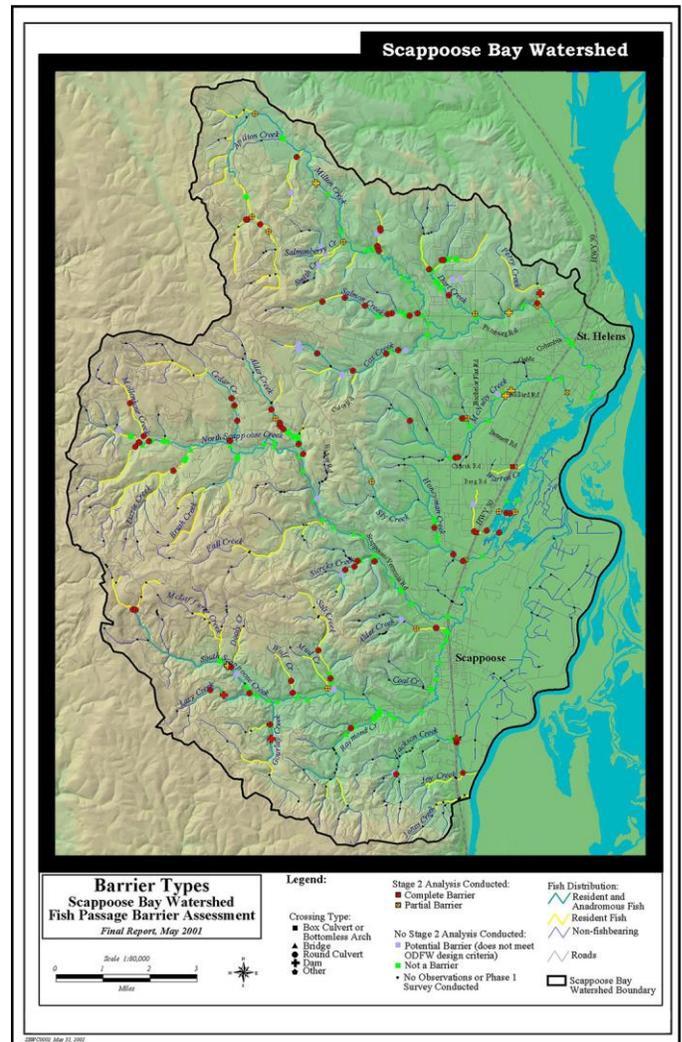
Figure 2-2. Types of barriers in the Scappoose Bay watershed identified in “A Comprehensive Assessment of Fish Passage Barriers in the Scappoose Bay Watershed.”

DEA personnel surveyed 293 crossings or potential obstructions of known fish-bearing streams. Of these, 131 did not meet Oregon Department of Fish and Wildlife (ODFW) design criteria for passage of juvenile and adult salmonids. More detailed surveys were done on 107 of these passages, including fish surveys and upstream and downstream conditions. Comparison of the Fish Passage Barrier map from the SBWA

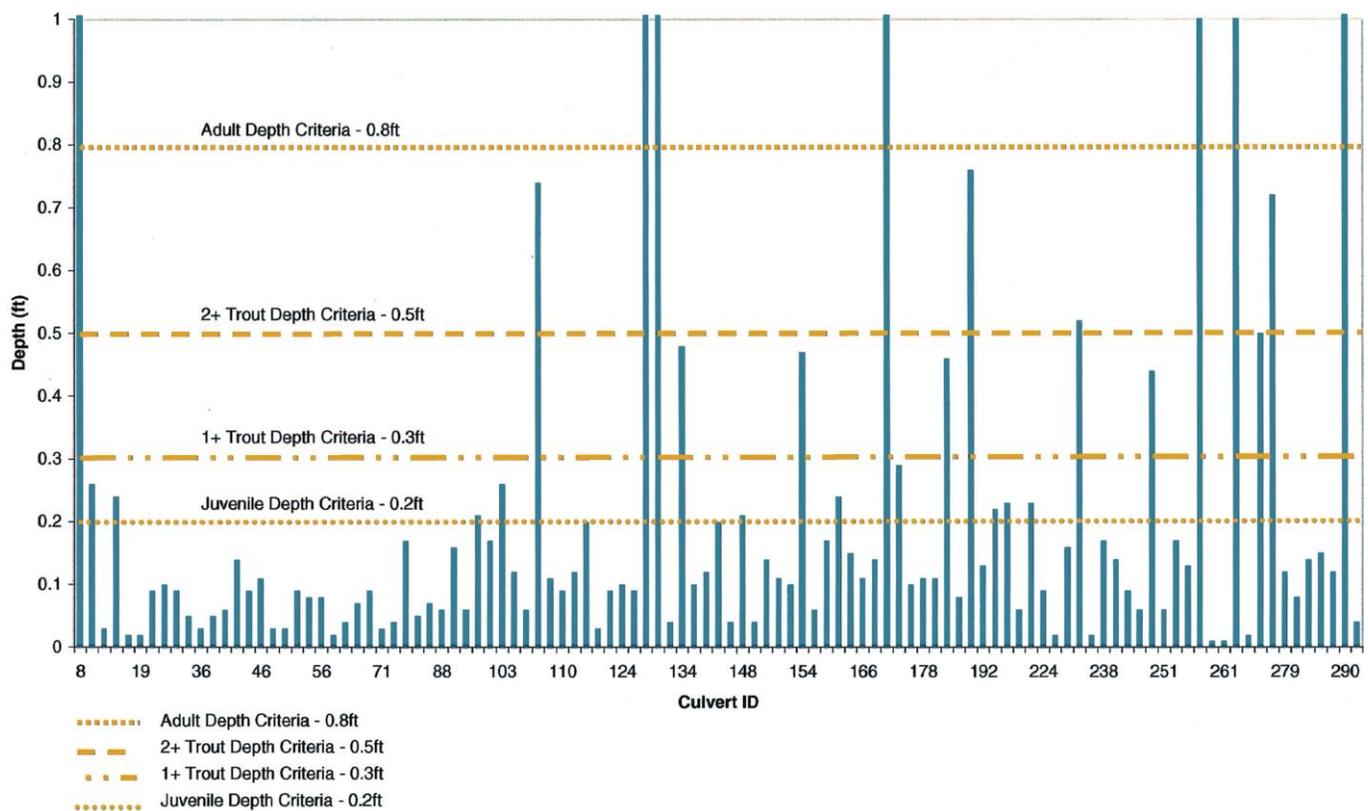
Figure 2-3. Results of the depth barrier assessment.

The second stage of the project used the detailed surveys to develop hydrologic and hydraulic analyses and to determine the severity of the barriers. This work included summarizing hydraulic analysis for depth, velocity, and leap barriers. Figure 2-3 shows the results of the depth barrier assessment.

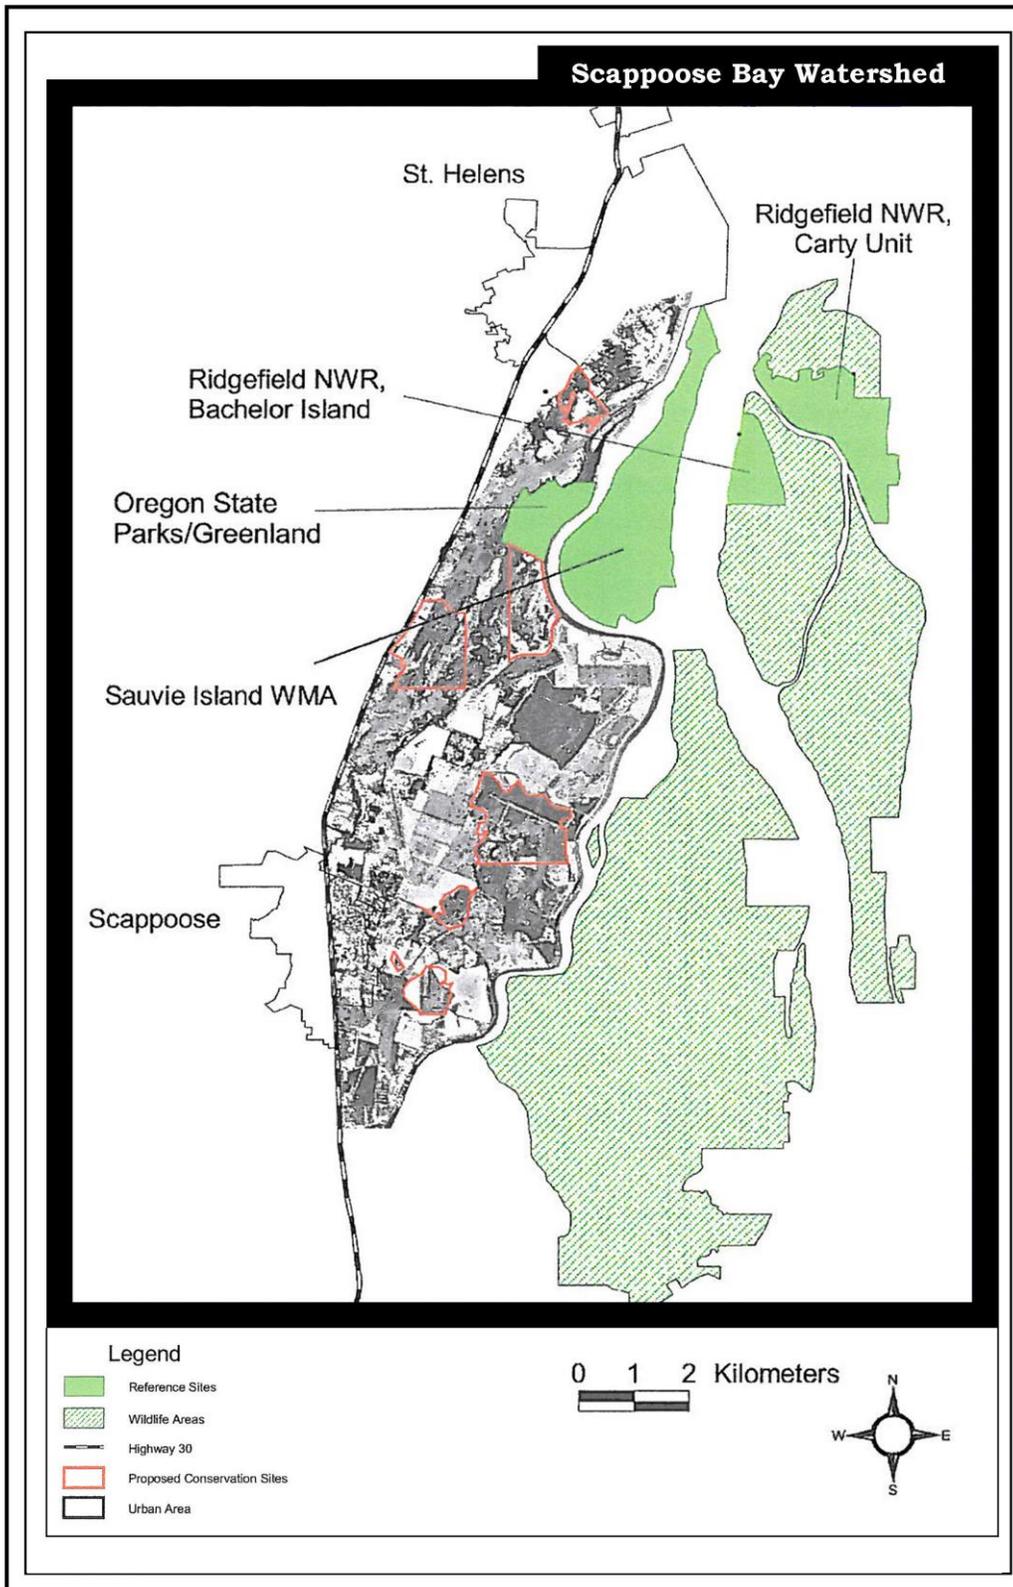
Figure 2-4. Scappoose wetlands proposed conservation sites, existing wildlife areas, and reference sites.

Figure 2-4 shows the sites where conservation strategies were determined (proposed conservation sites) in relation to the reference sites and existing wildlife areas.

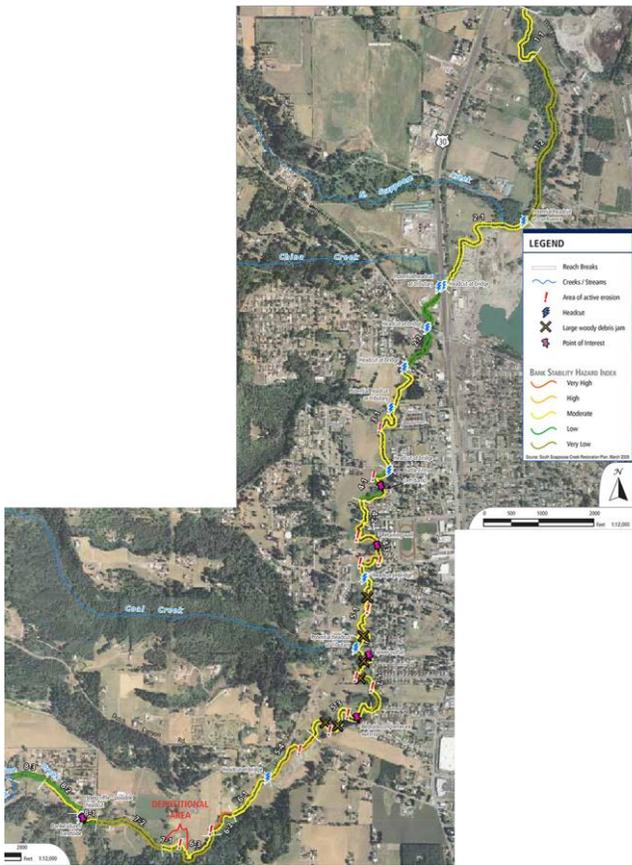
Figure 2-5. Bank and channel stability survey (Hazard Index), South Scappoose Creek.

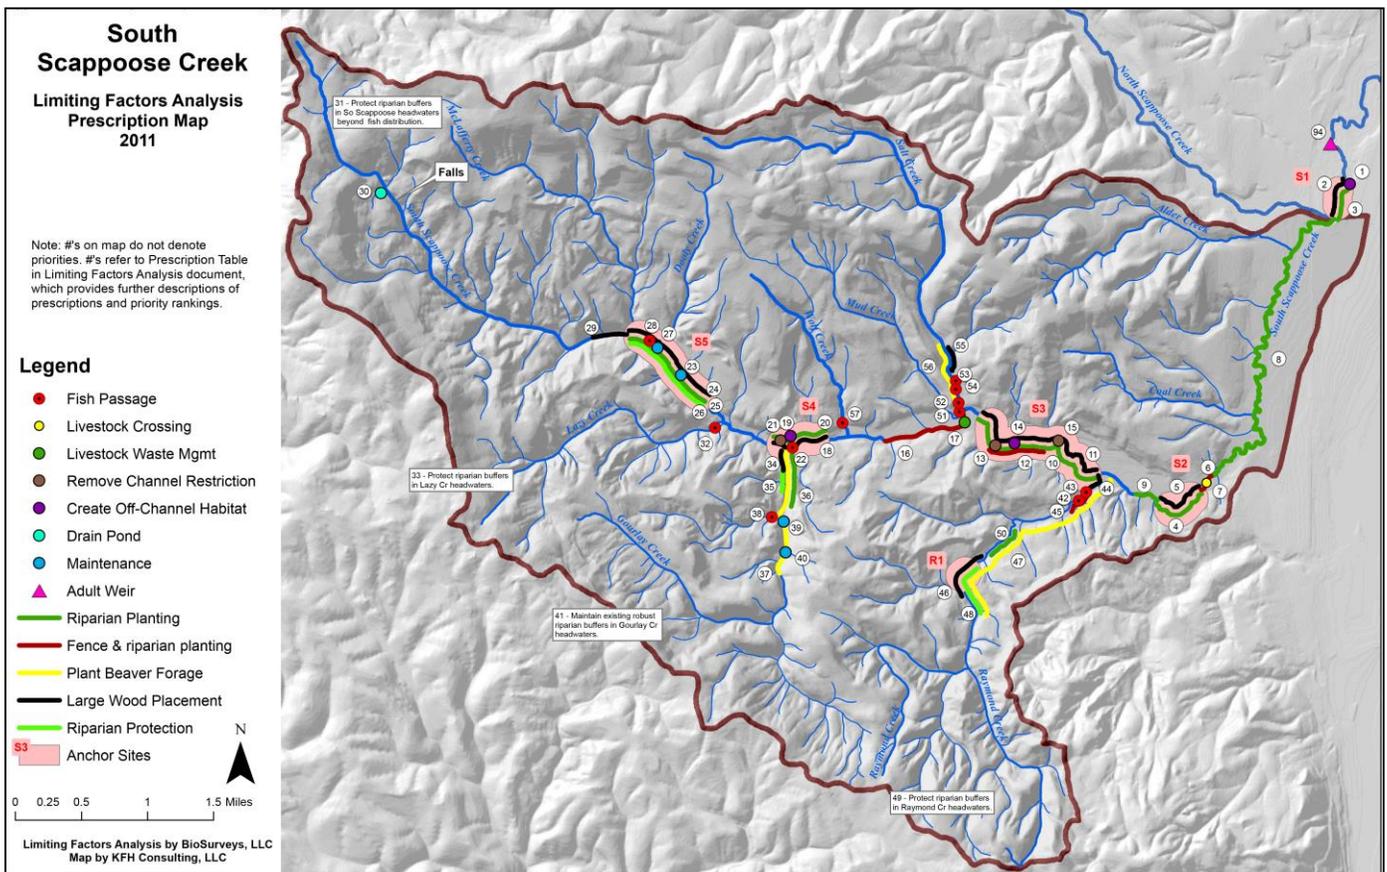
Figure 2-7. Limiting factors analysis prescription map for South Scappoose Creek.

Key pieces of the basin, called “anchor sites,” were identified. These sites have some level of a normal functional system and have high potential as effective restoration locations. Finally, a prescription map for restoration activities was produced for each sub-basin, along with a prioritized list of prescriptions. Figure 2-7 shows the prescription map for South Scappoose Creek.

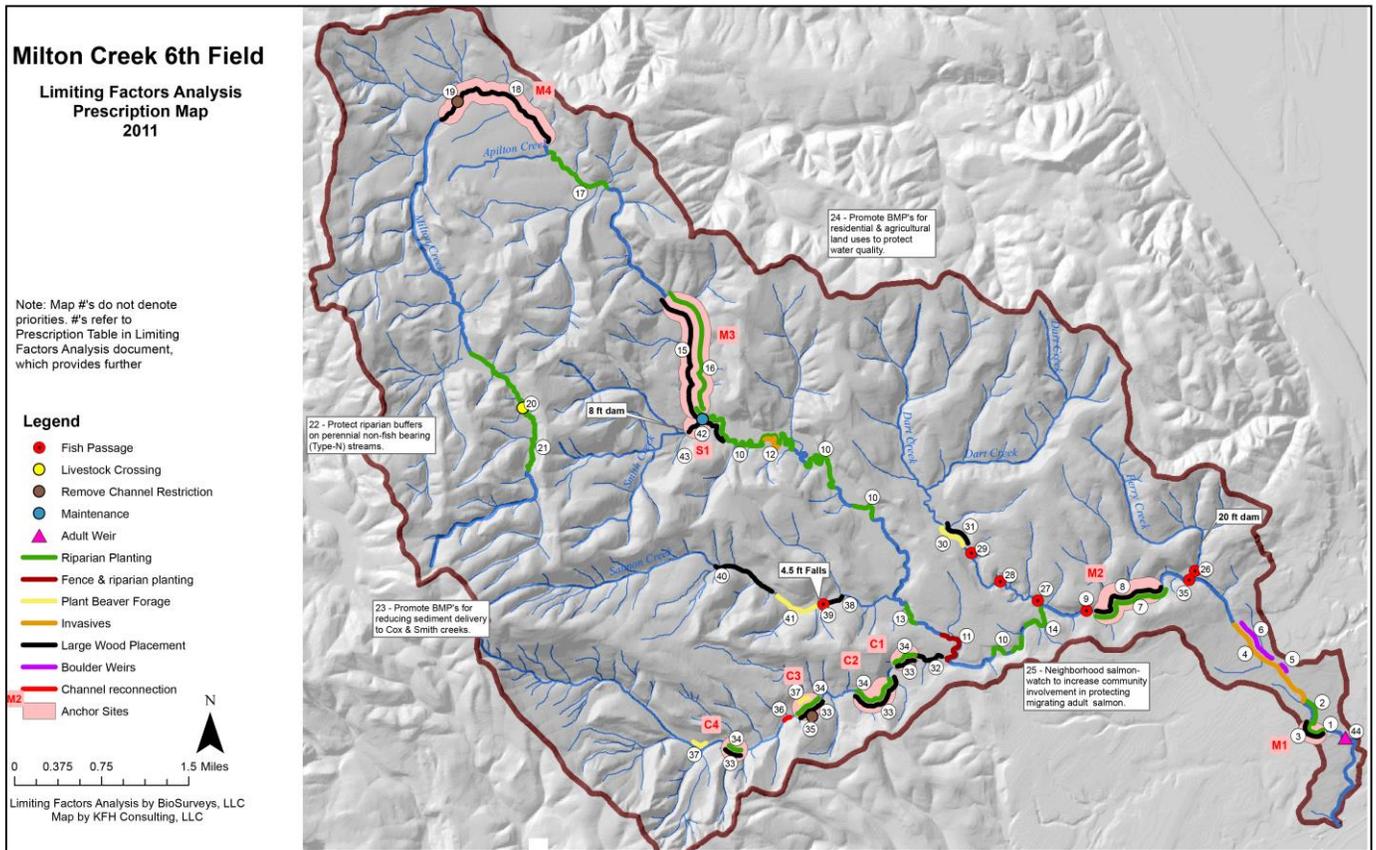
Figure 2-8. Limiting factors analysis prescription map of Milton Creek.

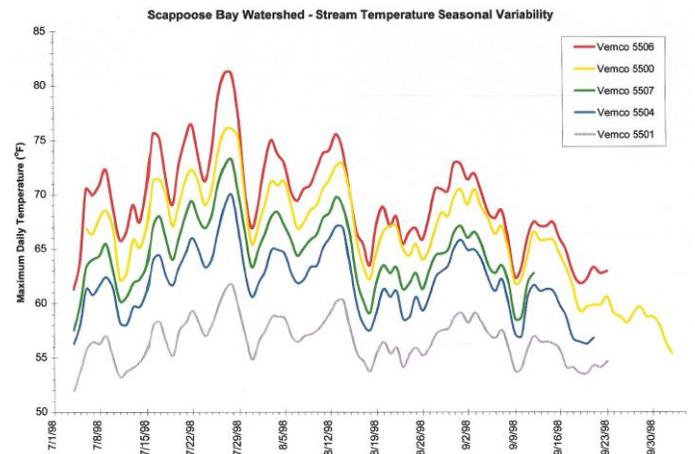
Figure 3-2. 1998 stream temperatures at five stations in Scappoose Creek.

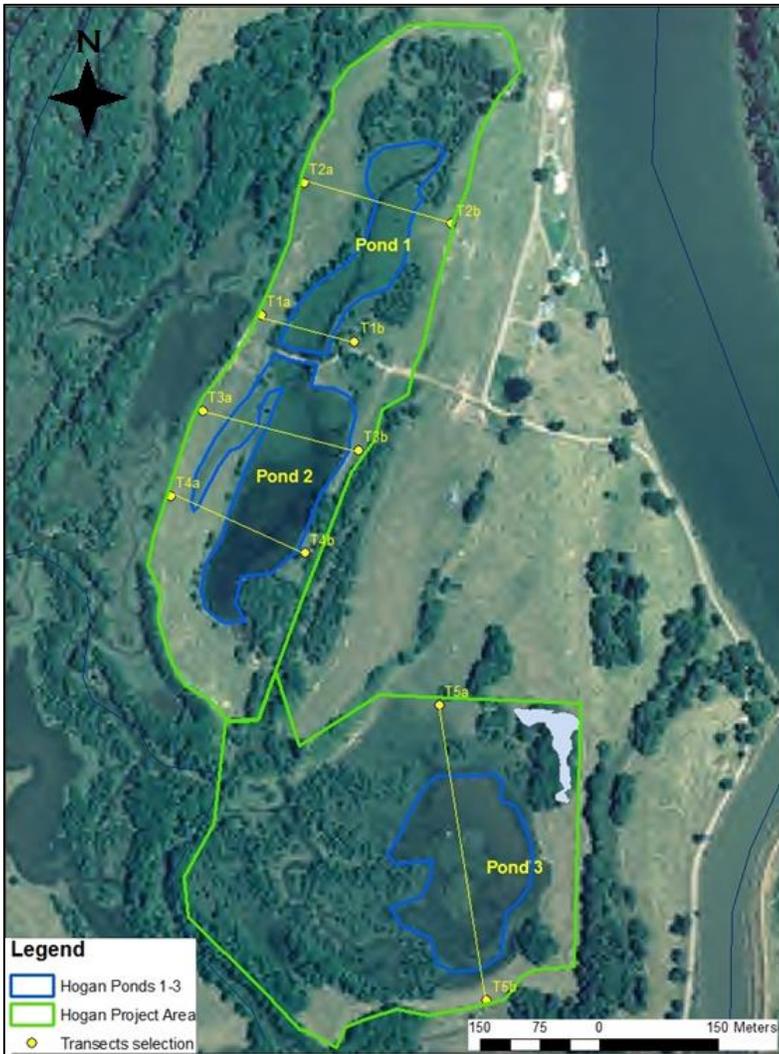
Figure 3-5. Hogan Ranch vegetation transects 2004–2011.

Vegetation transects were permanently established through each pond in 2004, three years prior to restoration (see Figure 3-5). The vegetation communities change abruptly along the hydrologic gradient across the ponds, going from a mix of upland grasses to wetland grass with a sparse willow overstory, to a wetland marsh edge community, and finally to submerged and floating vegetation in the pond. The width of each community along each transect was recorded in 2004 and from 2008 through 2011. Within each community, plant species were identified within plots that were randomly established. The total number of plots sampled varied by vegetation community and year, with a range of from 0 to 44 (large wetted area).

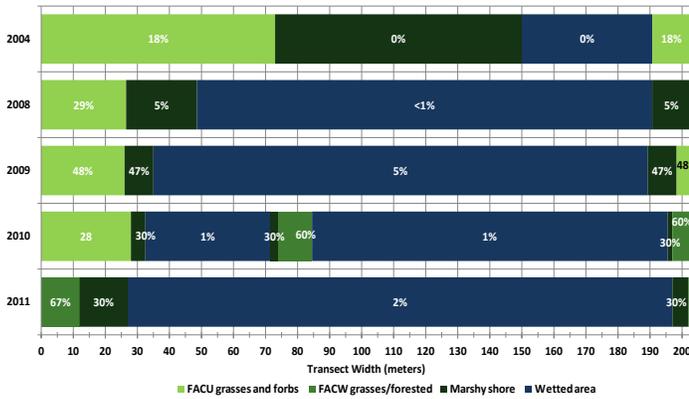
Figure 3-6. Plot showing changes to vegetation community widths at Pond 2.

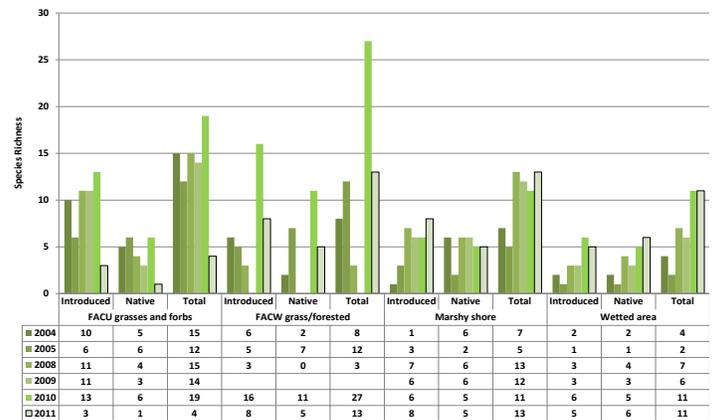
Figure 3-7. Plot showing community species richness at Pond 2.

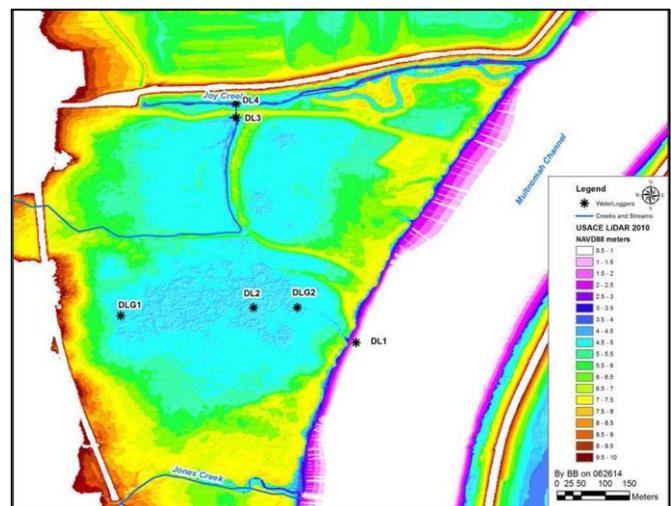
Figure 3-13. LiDAR map showing the locations of the pressure transducers in the wetlands.

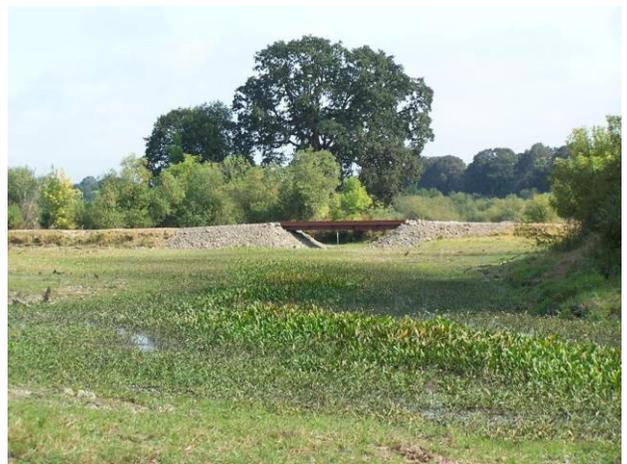
The completed bridge at Barrier #262. (SBWC photo)

Honeyman Creek flows through the Malarkey Ranch and out into the Scappoose Bay Bottomlands, near Warren, Oregon. This project addressed four unimproved road crossings that cut across slough and stream channels blocking fish passage and impairing hydrologic processes. Bridges were constructed to replace culverts on three of these crossings and to replace road fill across a slough on the fourth crossing.

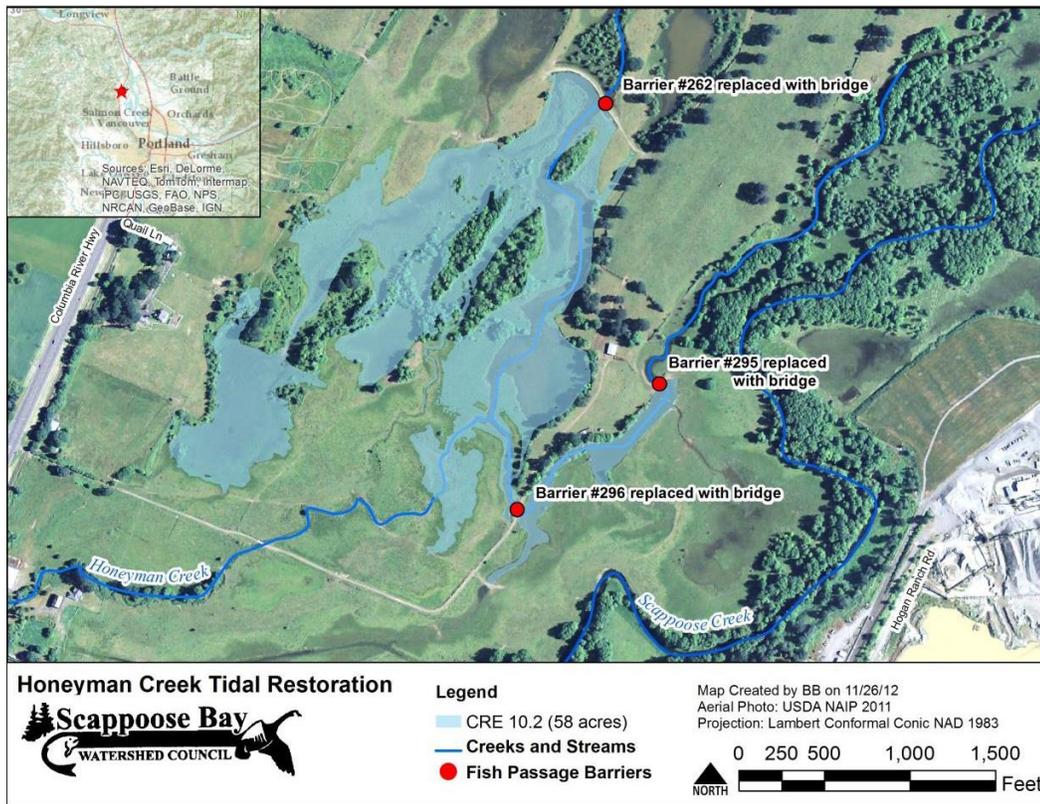
Figure 4-2. Location of the fish passage barriers in the Honeyman Creek project.

A significant achievement of this project was increasing the tidal fluctuations and frequency on the property, thereby improving the natural hydrogeomorphic processes to 54 acres of wetland habitat. This improvement also provided salmonids with access to these acres of freshwater tidal rearing habitat, as well as stream habitat in Honeyman Creek. Figure 4-2 shows a map of the fish passage barrier locations in the Scappoose Bay Bottomlands.

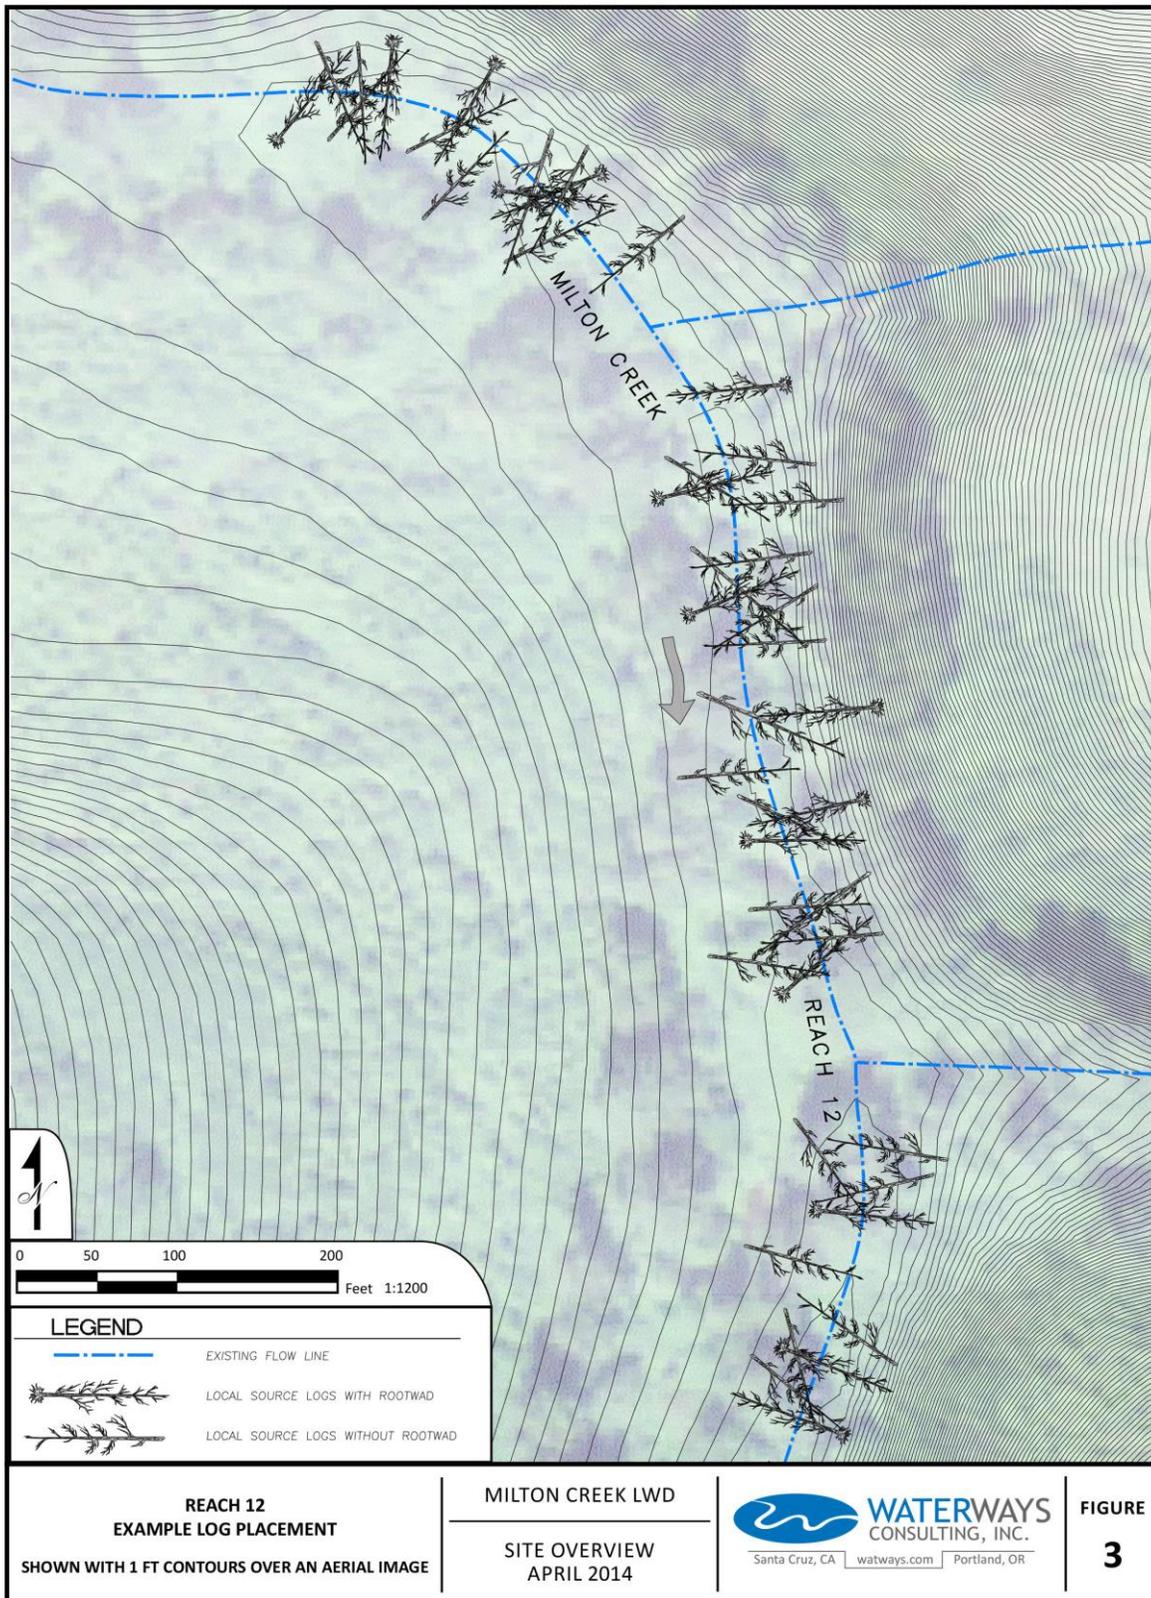
Figure 4-4. An example design for log placement for reaches of the Milton Creek Large Wood Enhancement Project.

The Milton Creek Large Wood Enhancement Project includes an assessment of the area for accessibility, availability of nearby wood, and ideal locations for wood placement along 15 reaches within this area. The city of St. Helens owns most of the land bordering this section of Milton Creek and manages it for forest production. The SBWC is partnering with the city on a proposal to implement the placement of wood designs, using timber within no-cut zones bordering the stream. Figure 4-4 shows an example of the log placement for Reach 12. The implementation project is expected to be constructed in 2015.

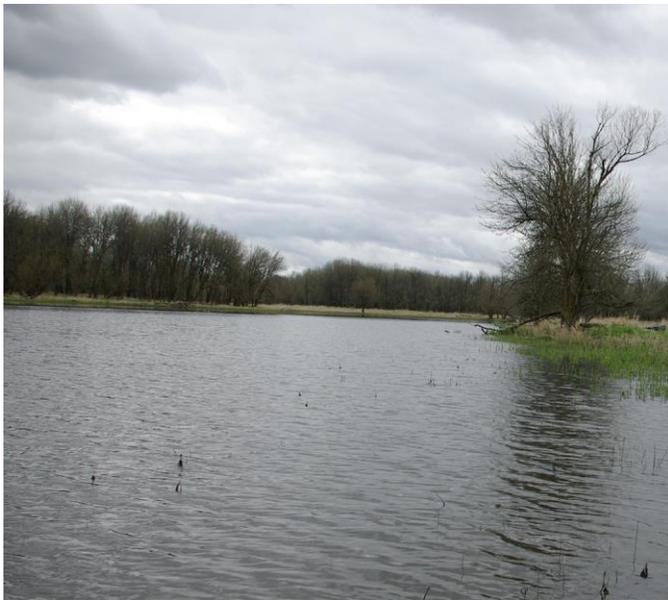
Figure 4-5. Photo point 9 on Hogan Ranch in 2008. (SBWC photo.)

Figure 4-5 and Figure 4-6 show the change in vegetation in Hogan Ranch in 2008 and 2014.

- Topographic and vegetation surveys were done in 2005, and fencing was constructed to exclude most cattle.
- In 2007, weed control and planting were done on 5 acres around Pond 1 (see Figure 3-4. Water quality and restoration sites at Hogan Ranch.).
- Additional trees were planted along Pond 3 in 2008, and Ponds 1 and 2 were prepped for large plantings.
- In 2009, 15 acres were planted around Ponds 1 and 2, and supplemental plantings were done on Pond 3.
- In 2010 and subsequent years, plantings were monitored using photo points, and the site was mowed as needed to reduce the cover of nonnative vegetation, including reed canary grass.

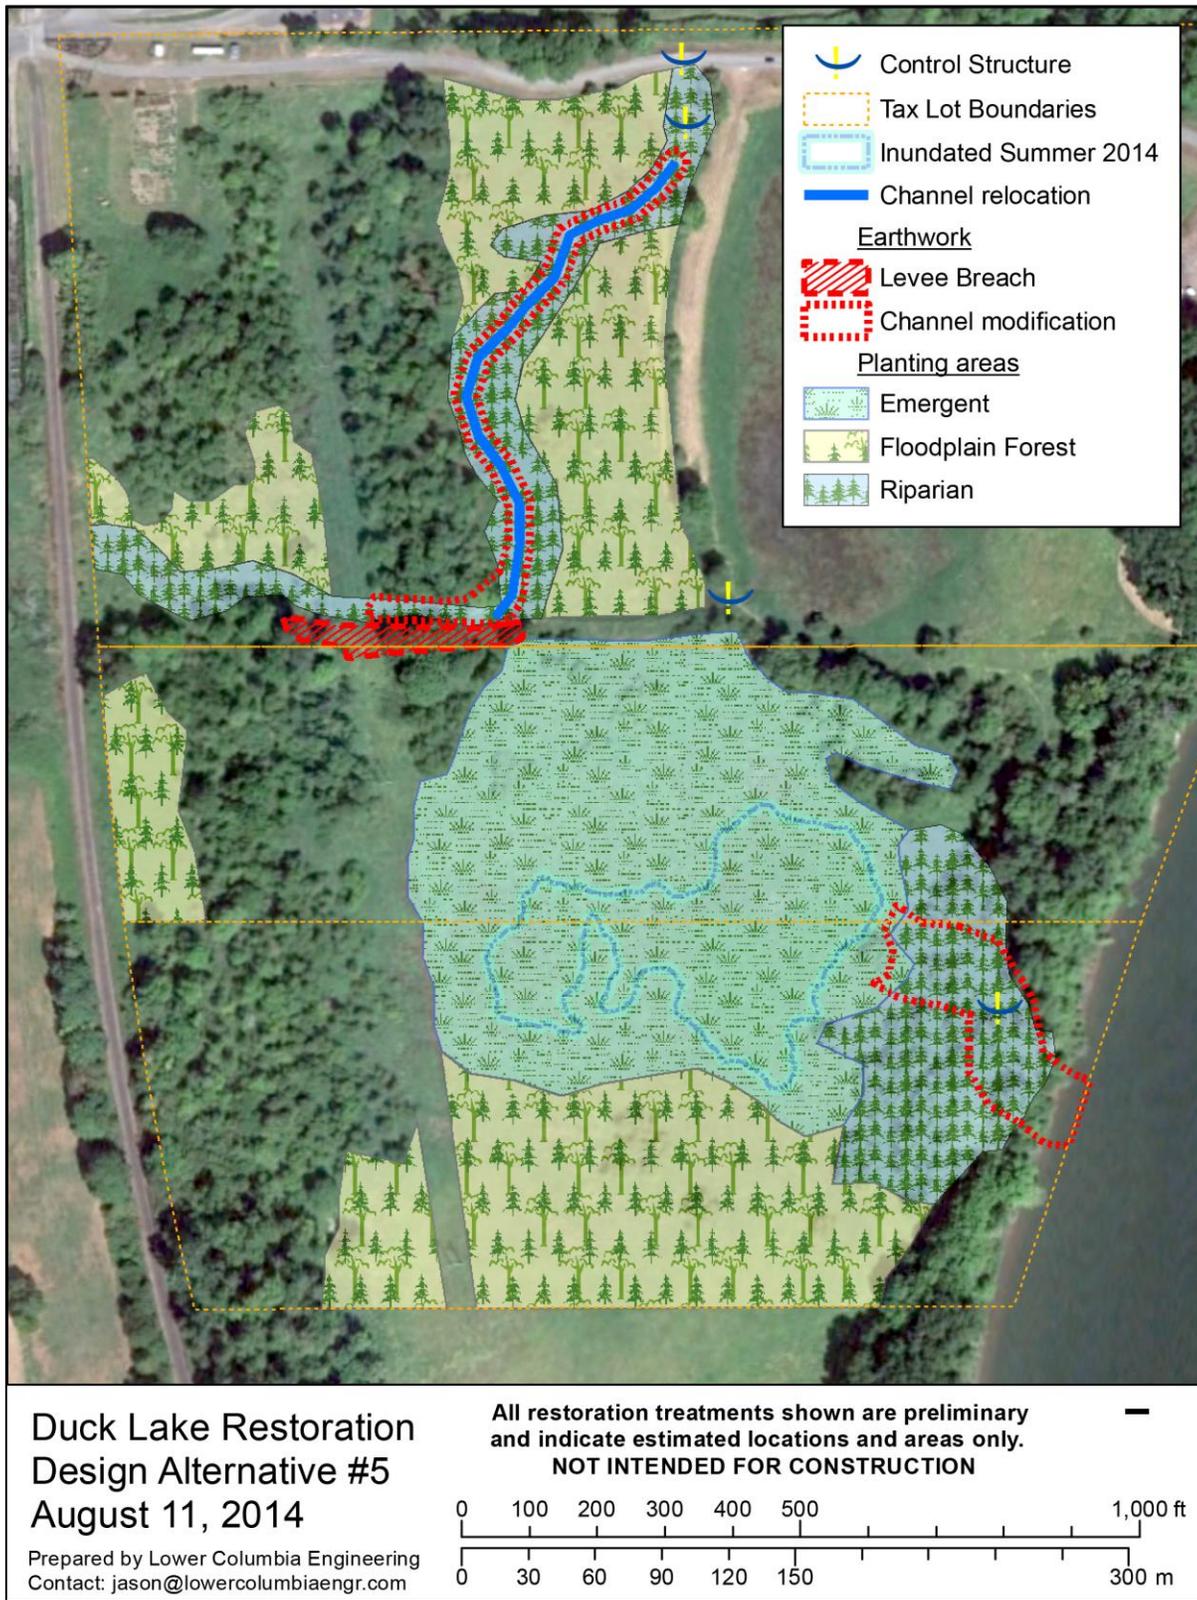
Figure 4-7. Map showing design alternative 5 at Duck Lake restoration.

The landowners are currently considering the proposed alternatives. The next phase of the project will be to develop final design plans for the chosen restoration work. This phase is scheduled for 2015, with construction in 2016.

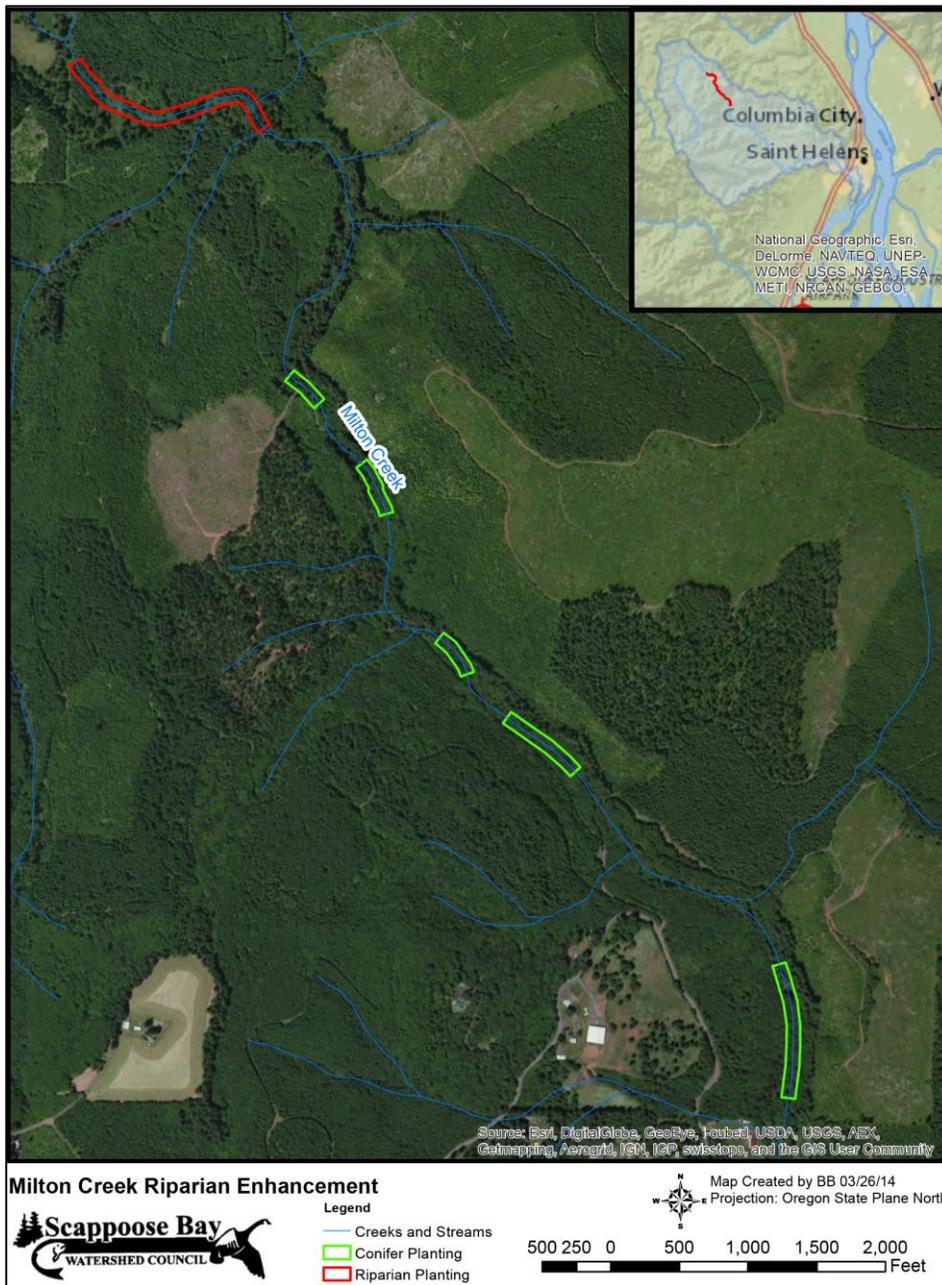
Figure 6-3. Map of conifer and riparian planting areas around Milton Creek.

An additional grant from DEQ will enhance the wood placement project through riparian restoration. That work will include invasive weed management on 2.5 acres in the upper reaches of this stretch of the creek, plus planting of native conifers and other riparian vegetation in 8.5 acres. A map of the conifer and riparian planting areas is shown in Figure 6-3.
